Debris/Ice/TPS Assessment And Photographic Analysis For Shuttle Mission STS-43

September 1991

DEBRIS/ICE/TPS ASSESSMENT
AND
PHOTOGRAPHIC ANALYSIS
OF
- SHUTTLE MISSION STS-43

August 2, 1991

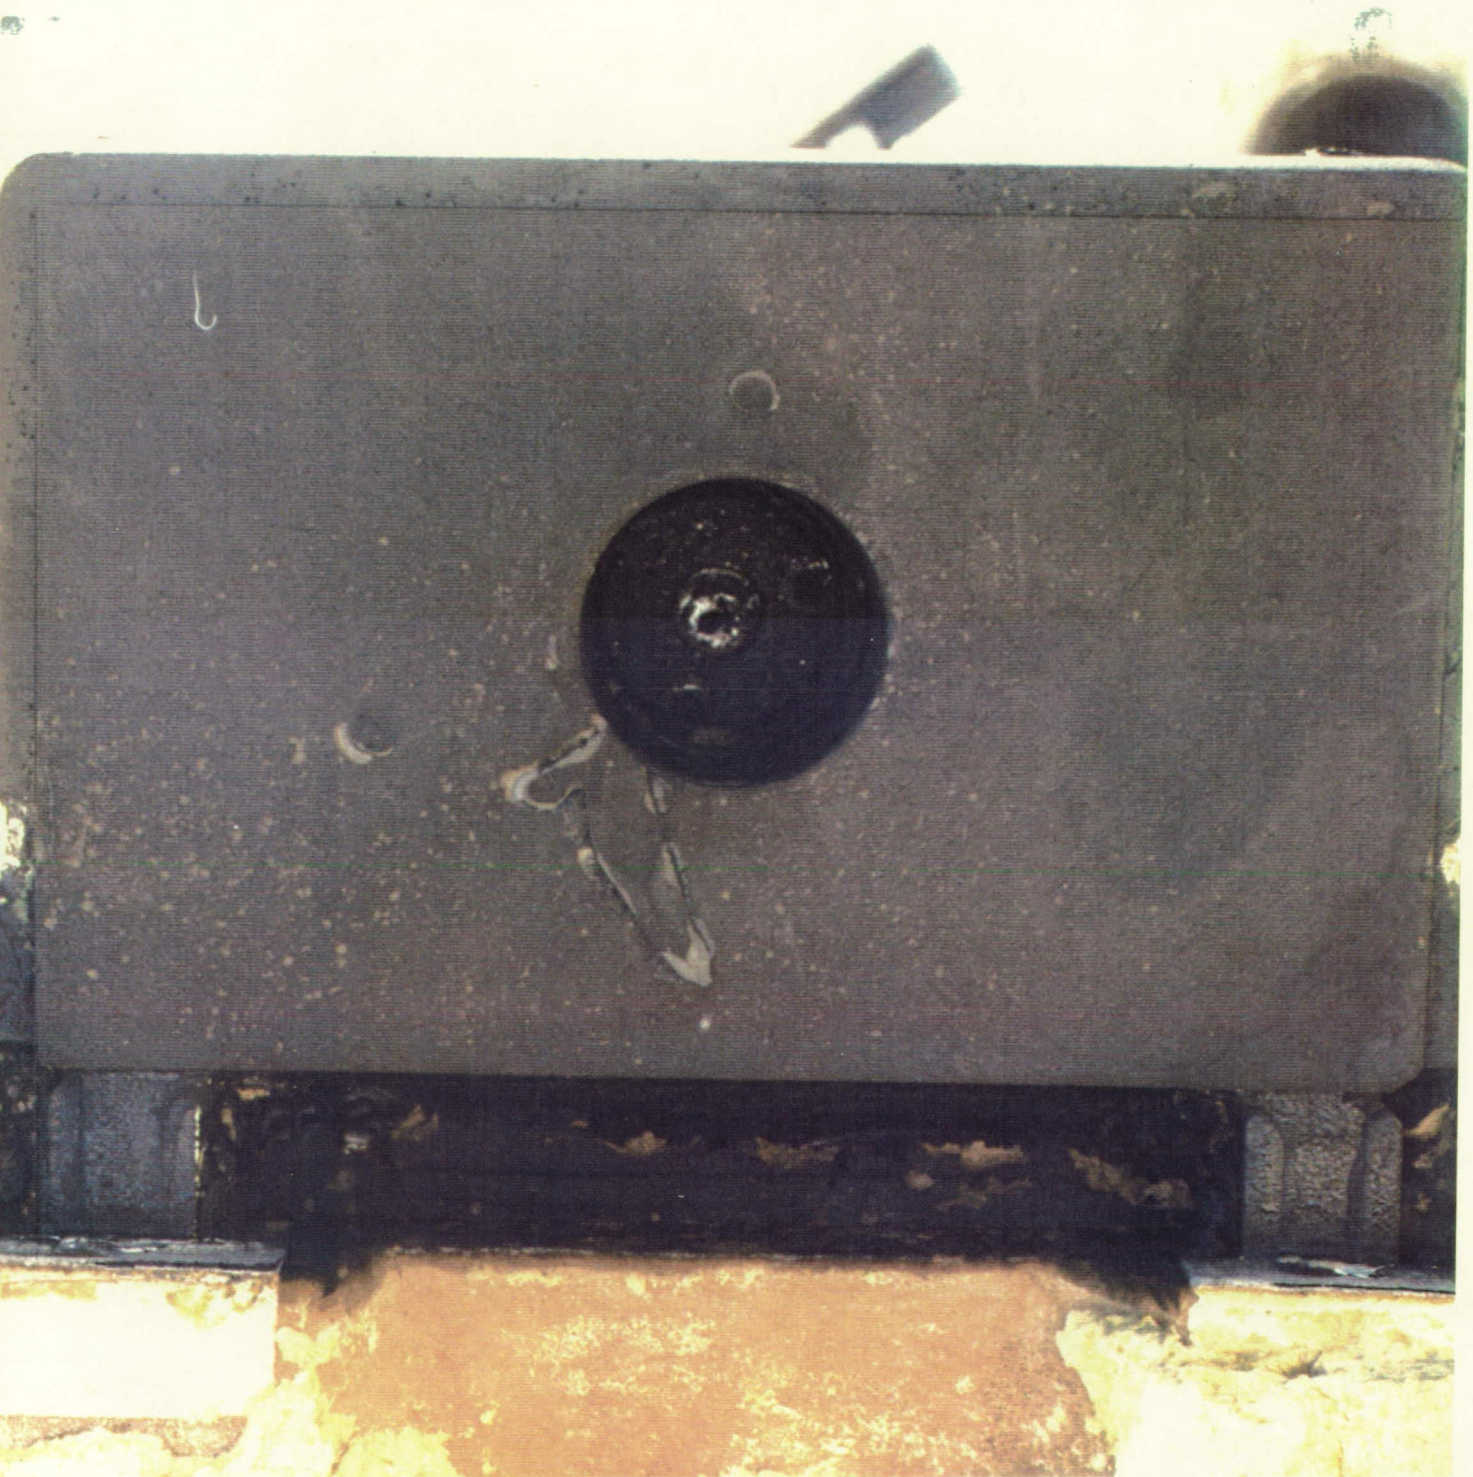
All of the HDP #3 EPON shim material was intact. Shim material should remain attached to the aft skirt during flight.

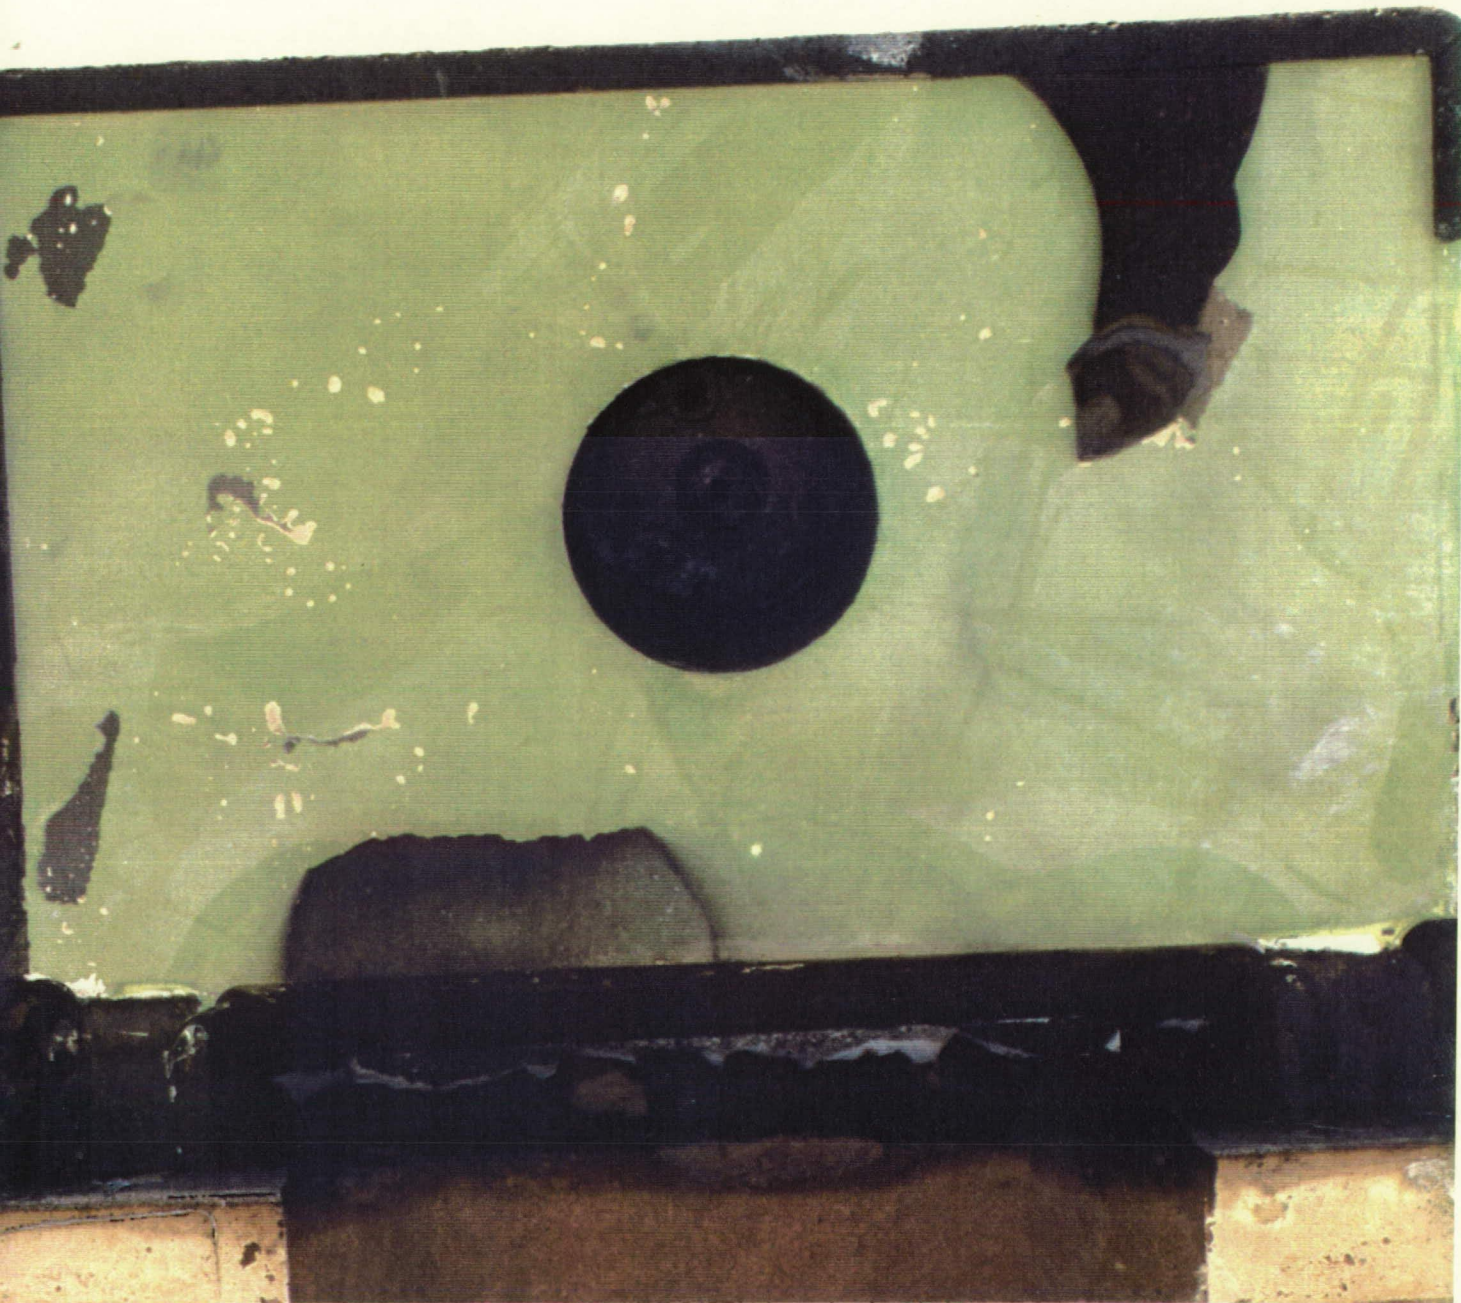
Most of the HDP #4 EPON shim material was lost at water impact except for a 5"x2.5" area, which showed a charred substrate.

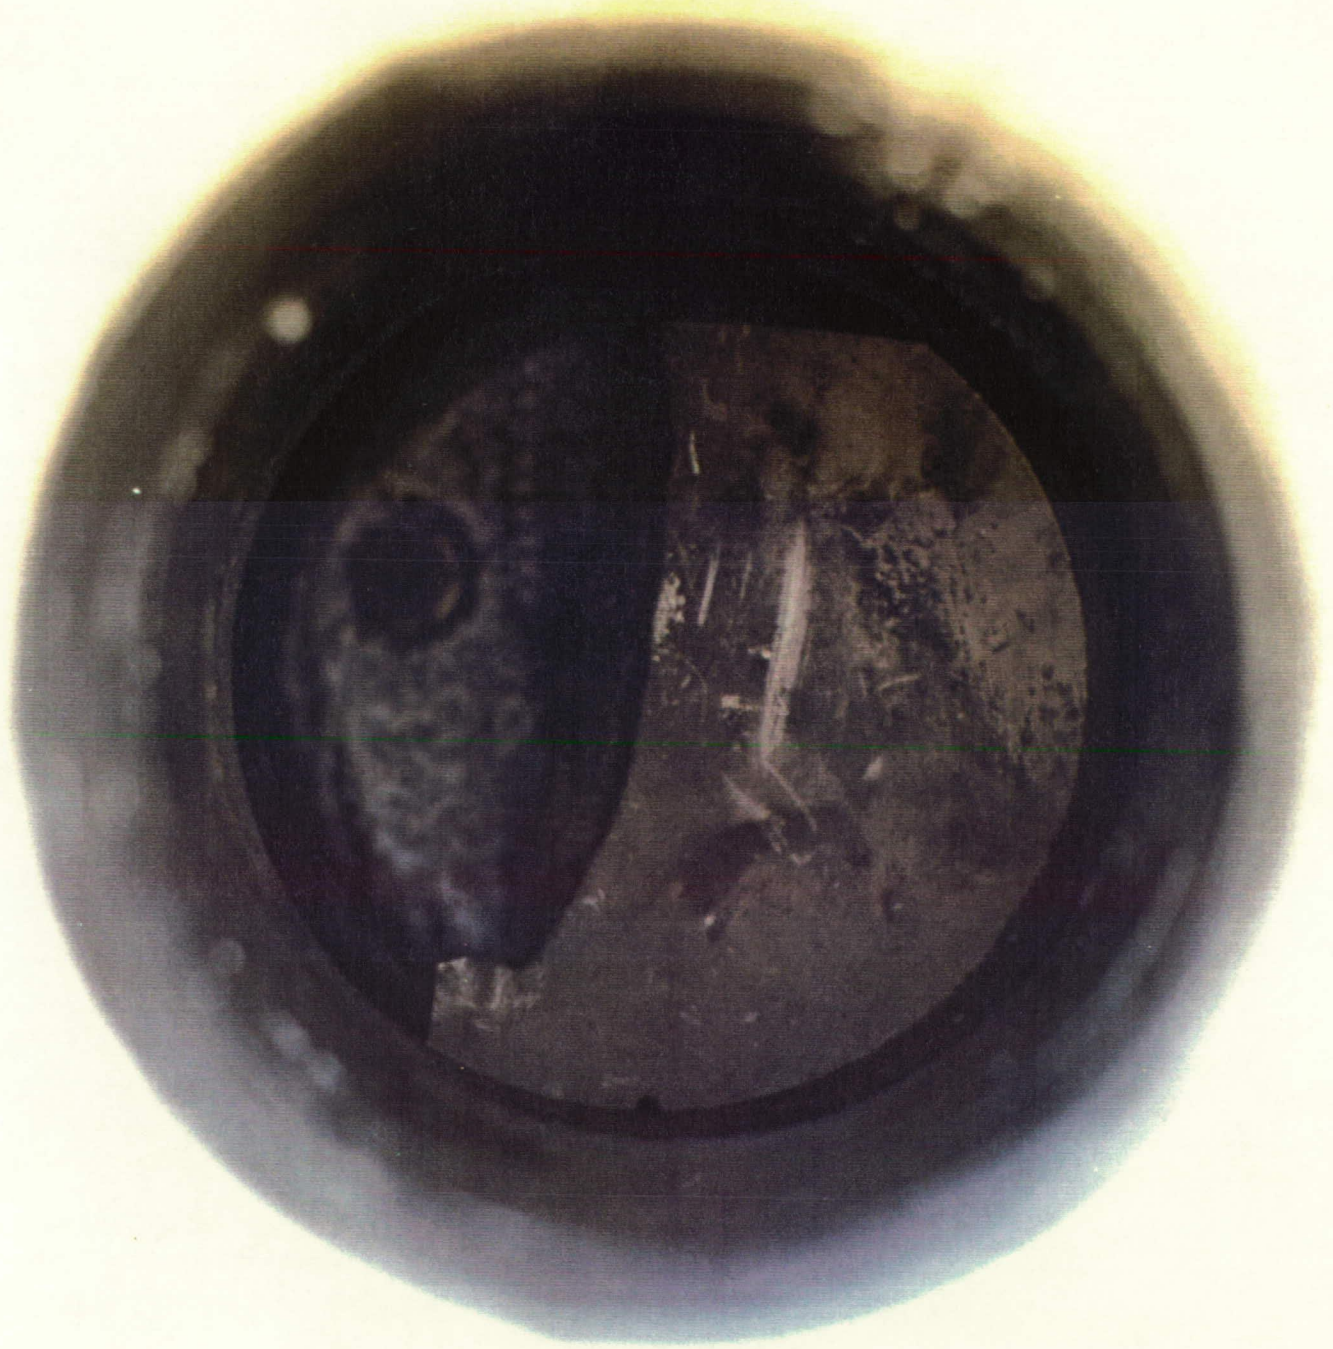
The HDP #2 DCS plunger was obstructed by a frangible nut half

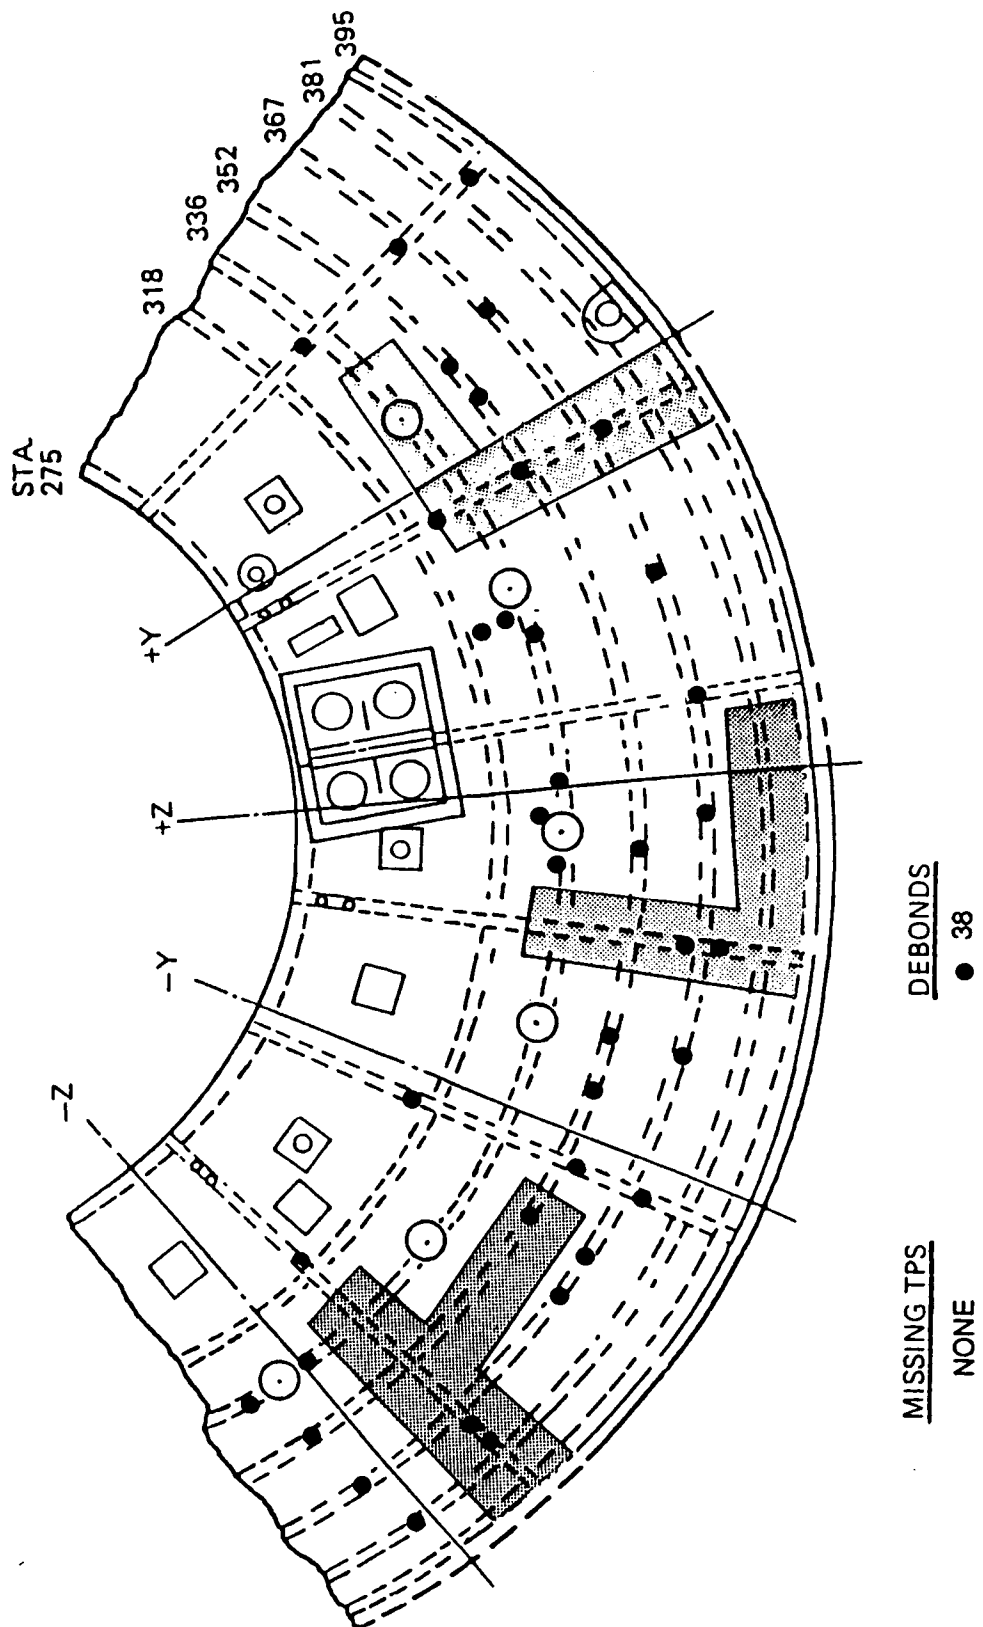
FIGURE 12. LEFT SRB FRUSTRUM

The LH frustum exhibited no missing TPS but had 38 MSA-2 debonds over fasteners (Figure 12). Minor blistering of the Hypalon paint occurred at three locations. All BSM covers were locked in the fully opened position.

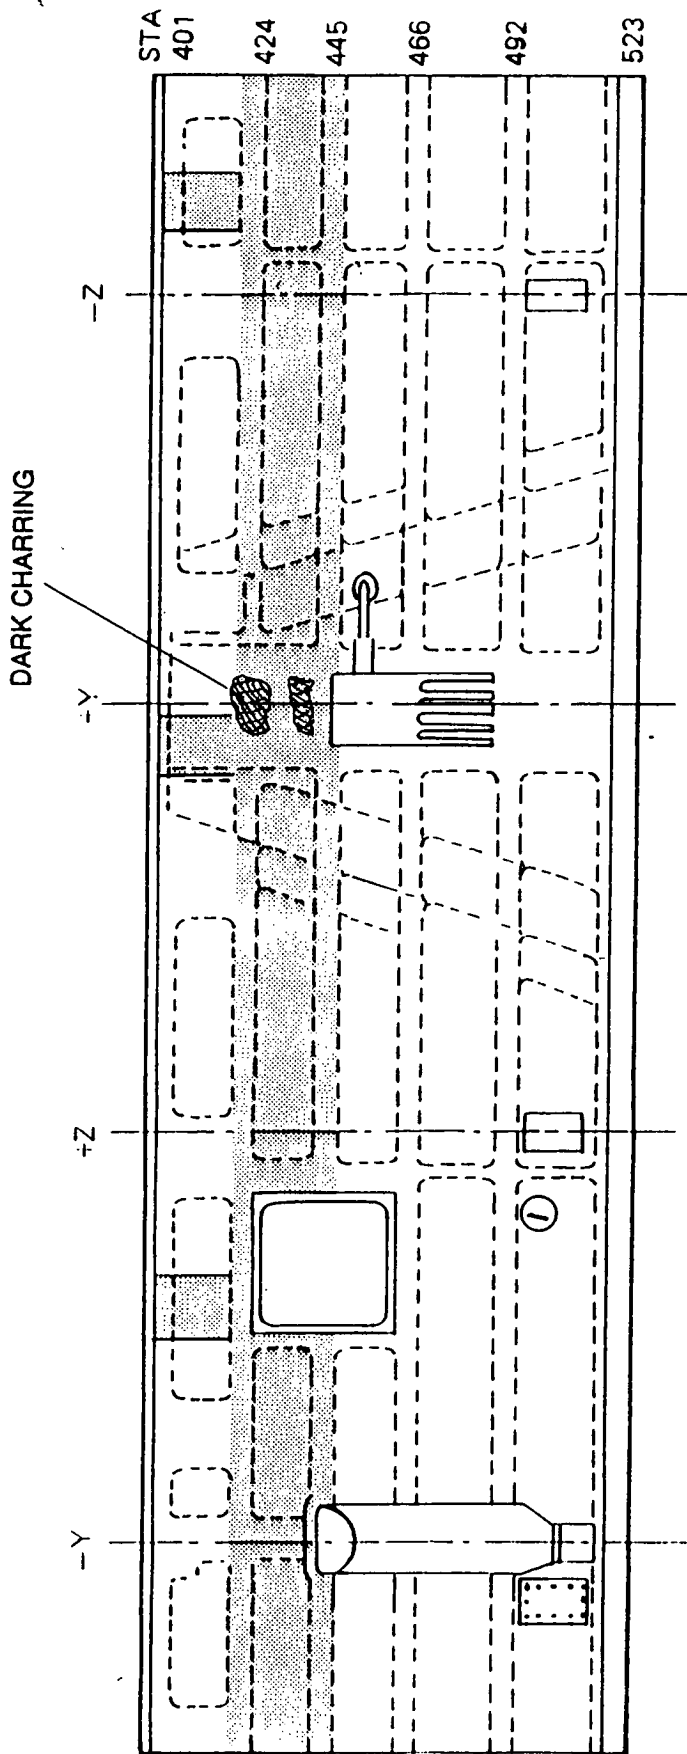
FIGURE 13.

The LH forward skirt exhibited no debonds. MSA-2, 2.5"x1" in size, was missing from an area one foot forward of the skirt clevis and one foot outboard of the +Z RSS antenna (aft of the flight door). The phenolic plates on both RSS antennae were intact. At least one layer of the phenolic plate on the +Z antenna was delaminated. The forward separation bolt and electrical cables appeared to have separated cleanly. No pins were missing from the frustum severance ring. Minor blistering of the Hypalon paint occurred forward of the ET/SRB attach point (Figure 13).

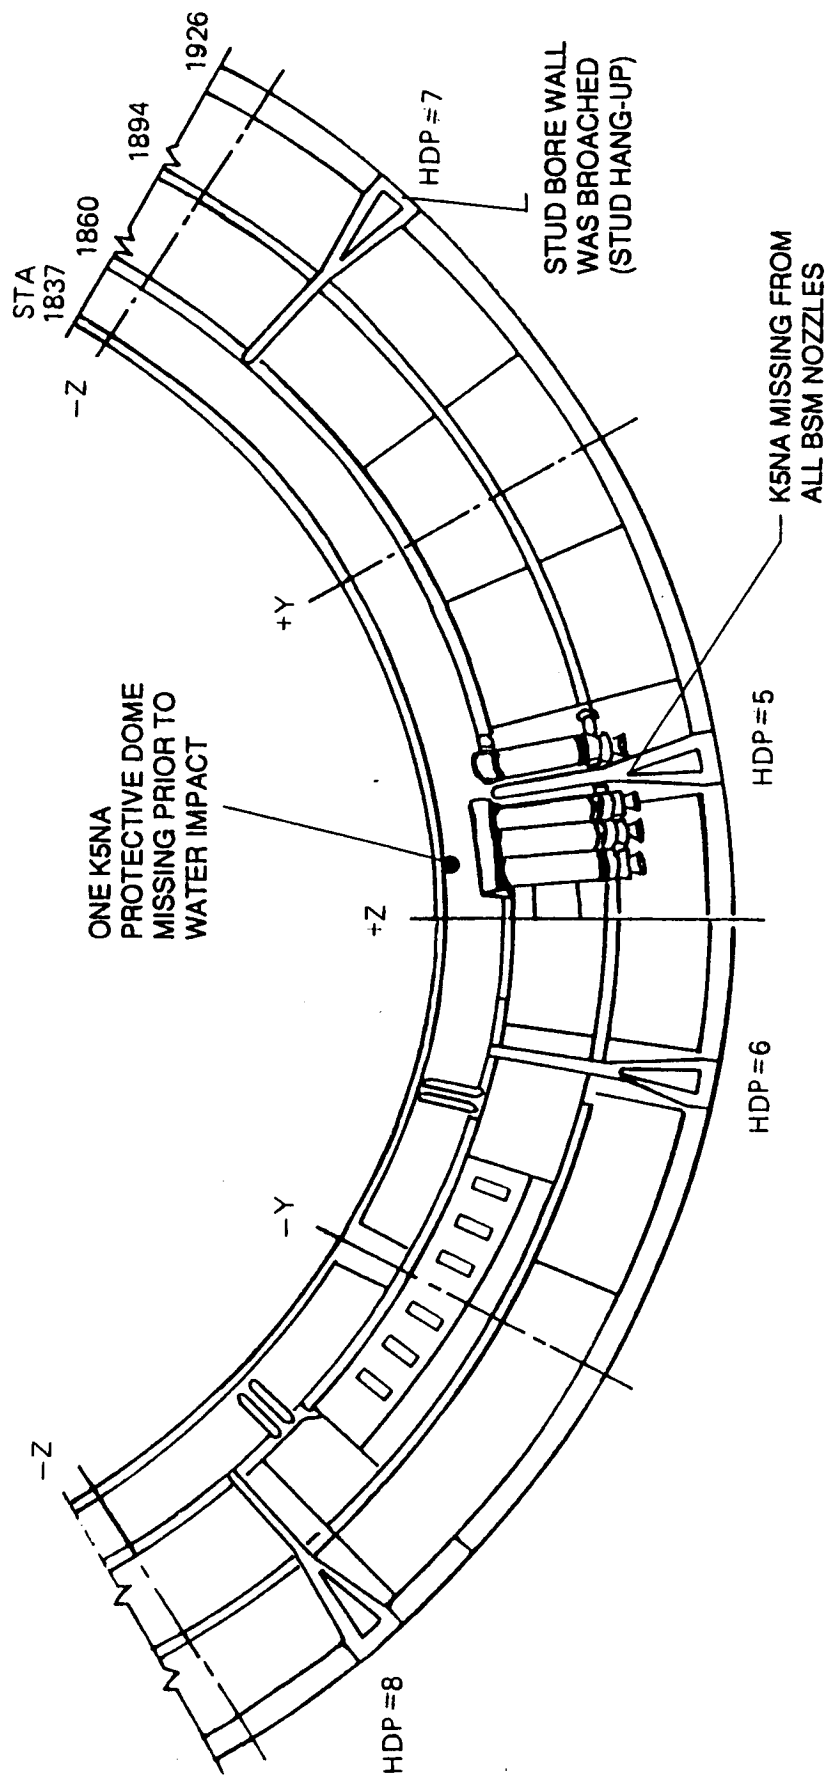
FIGURE 14.

The phenolic material on the kick ring delaminated at several locations. One K5NA protective dome was lost from a bolt head on the aft side of the phenolic kick ring near HDP #5 prior to water impact. The aft skirt acreage TPS was in good condition (Figure 14). K5NA was missing from all aft BSM nozzles.

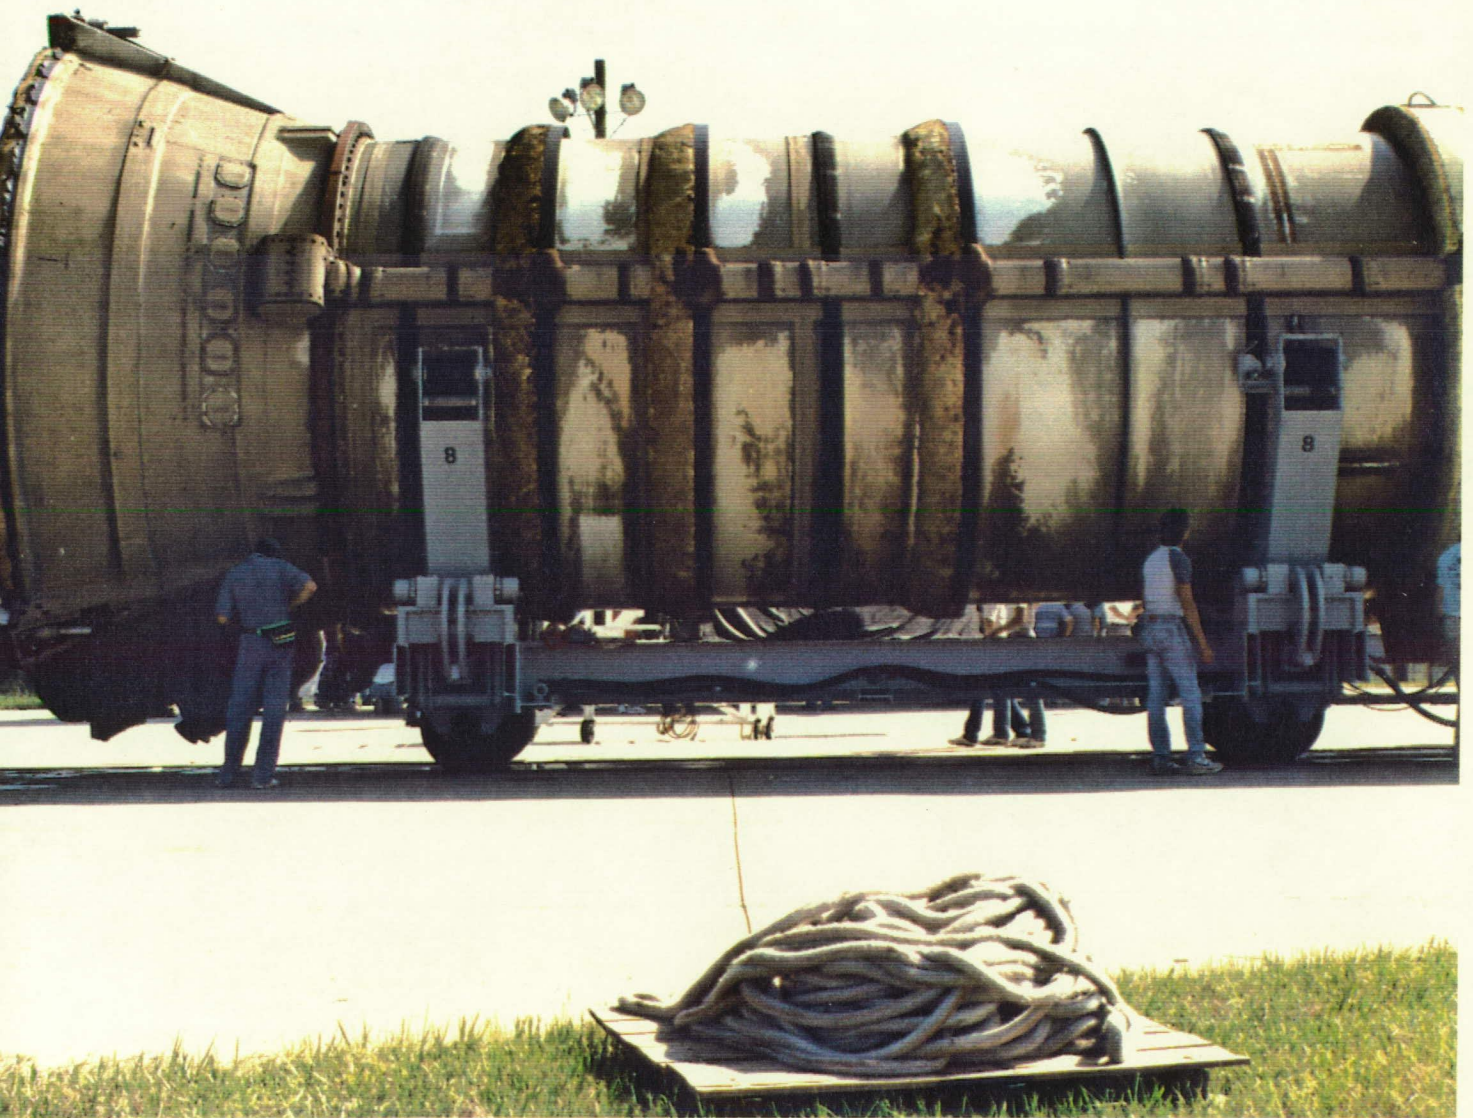
Post flight condition of the LH aft booster/aft skirt
The aft skirt acreage TPS was generally in good condition

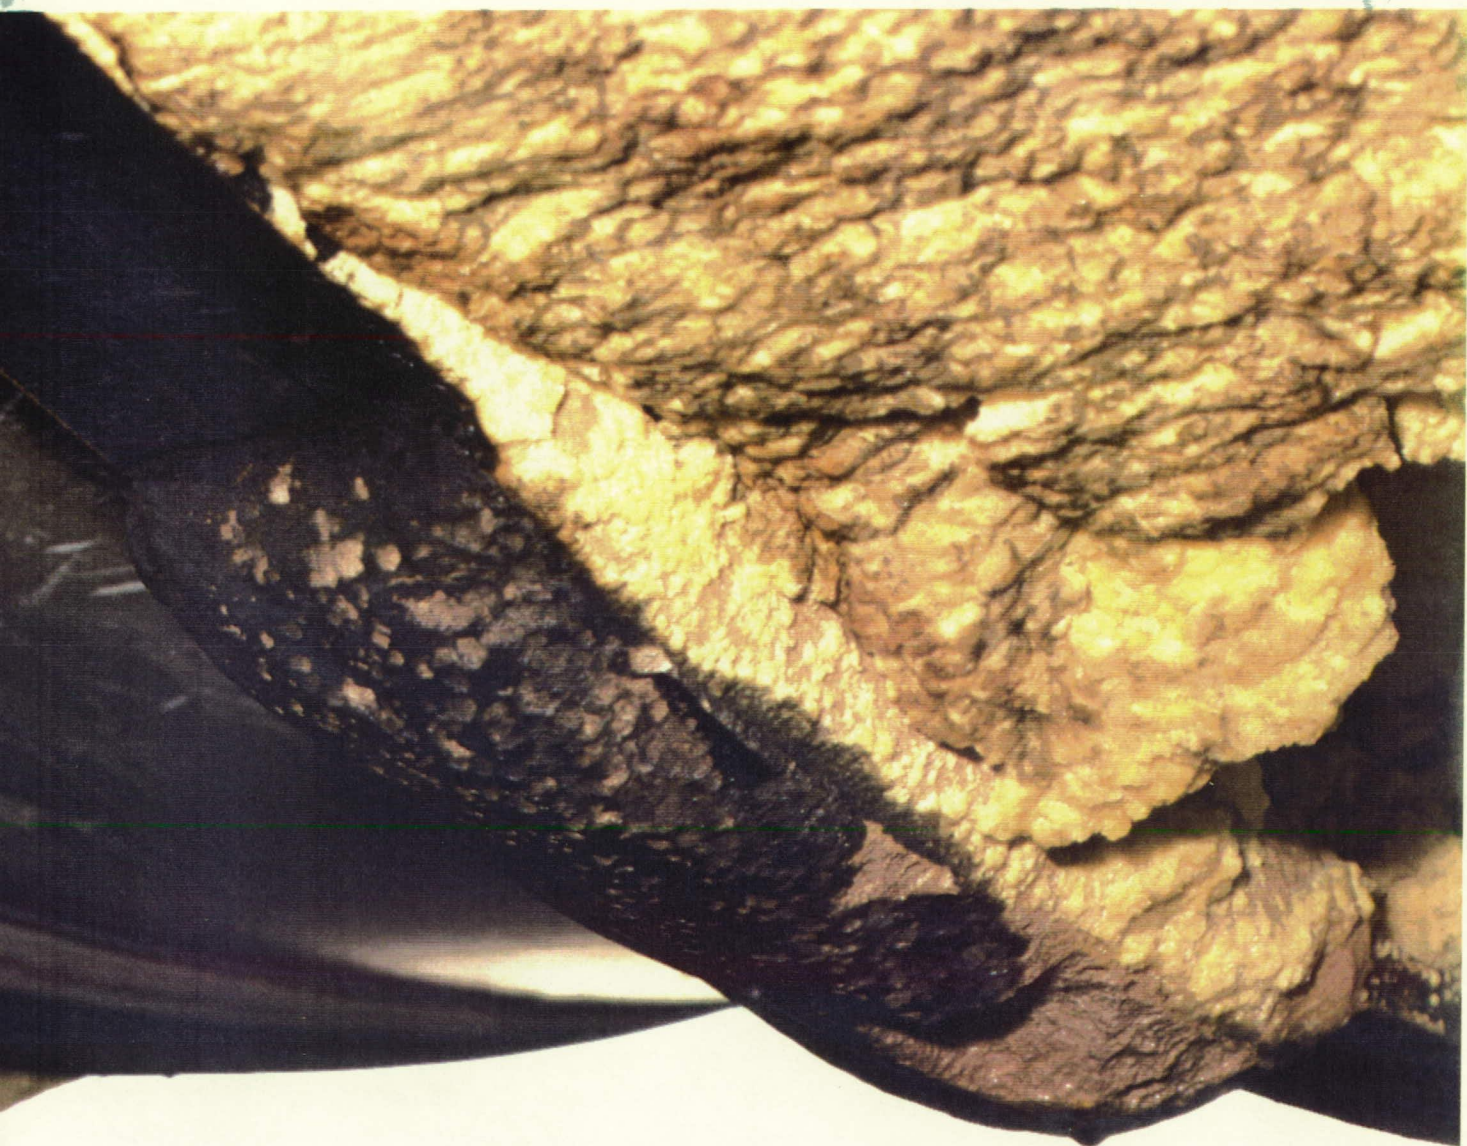
The aft booster stiffener ring splice plate closeouts were intact and no K5NA material was missing prior to water impact.

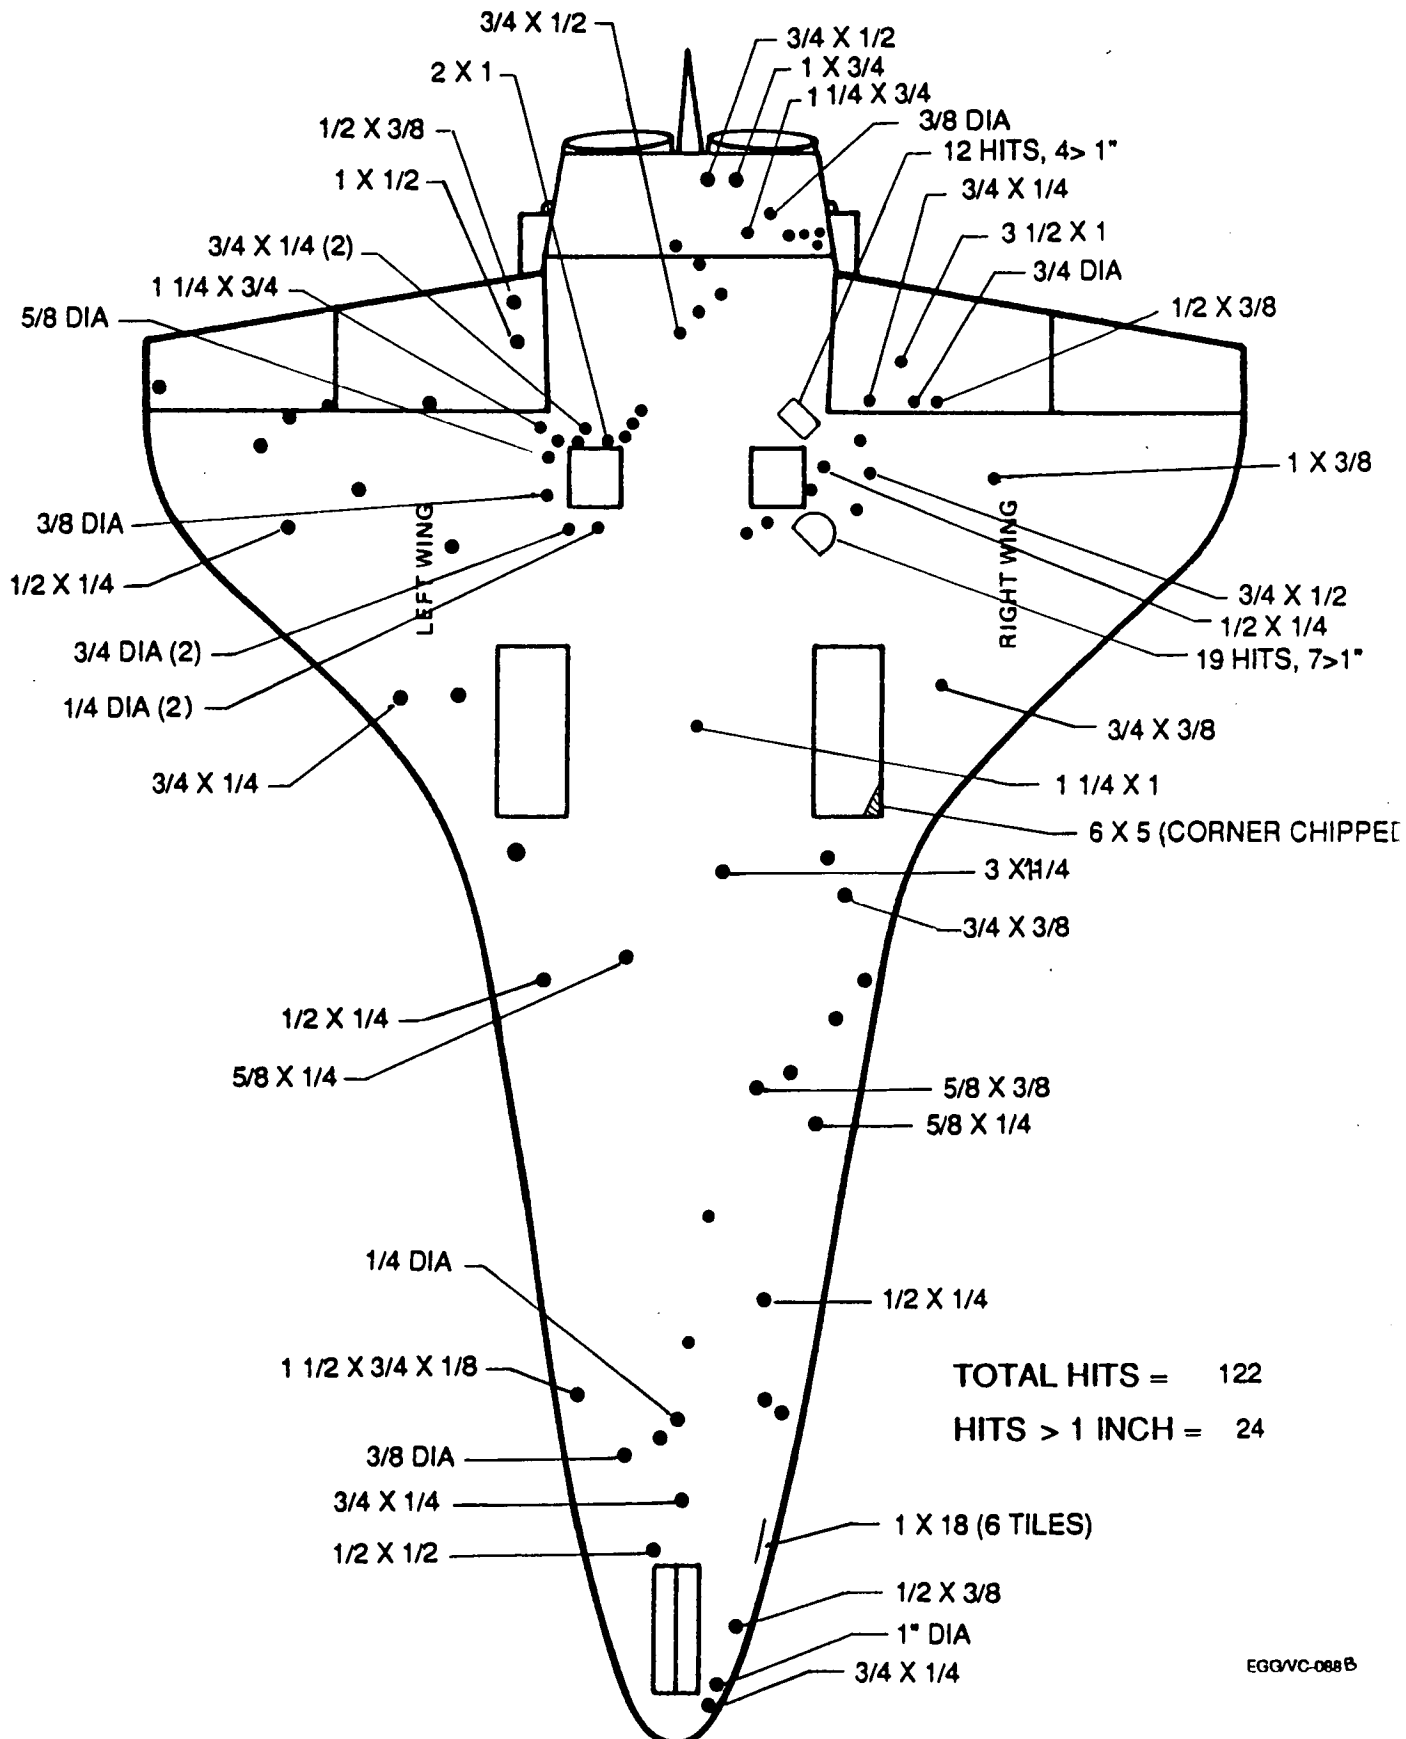
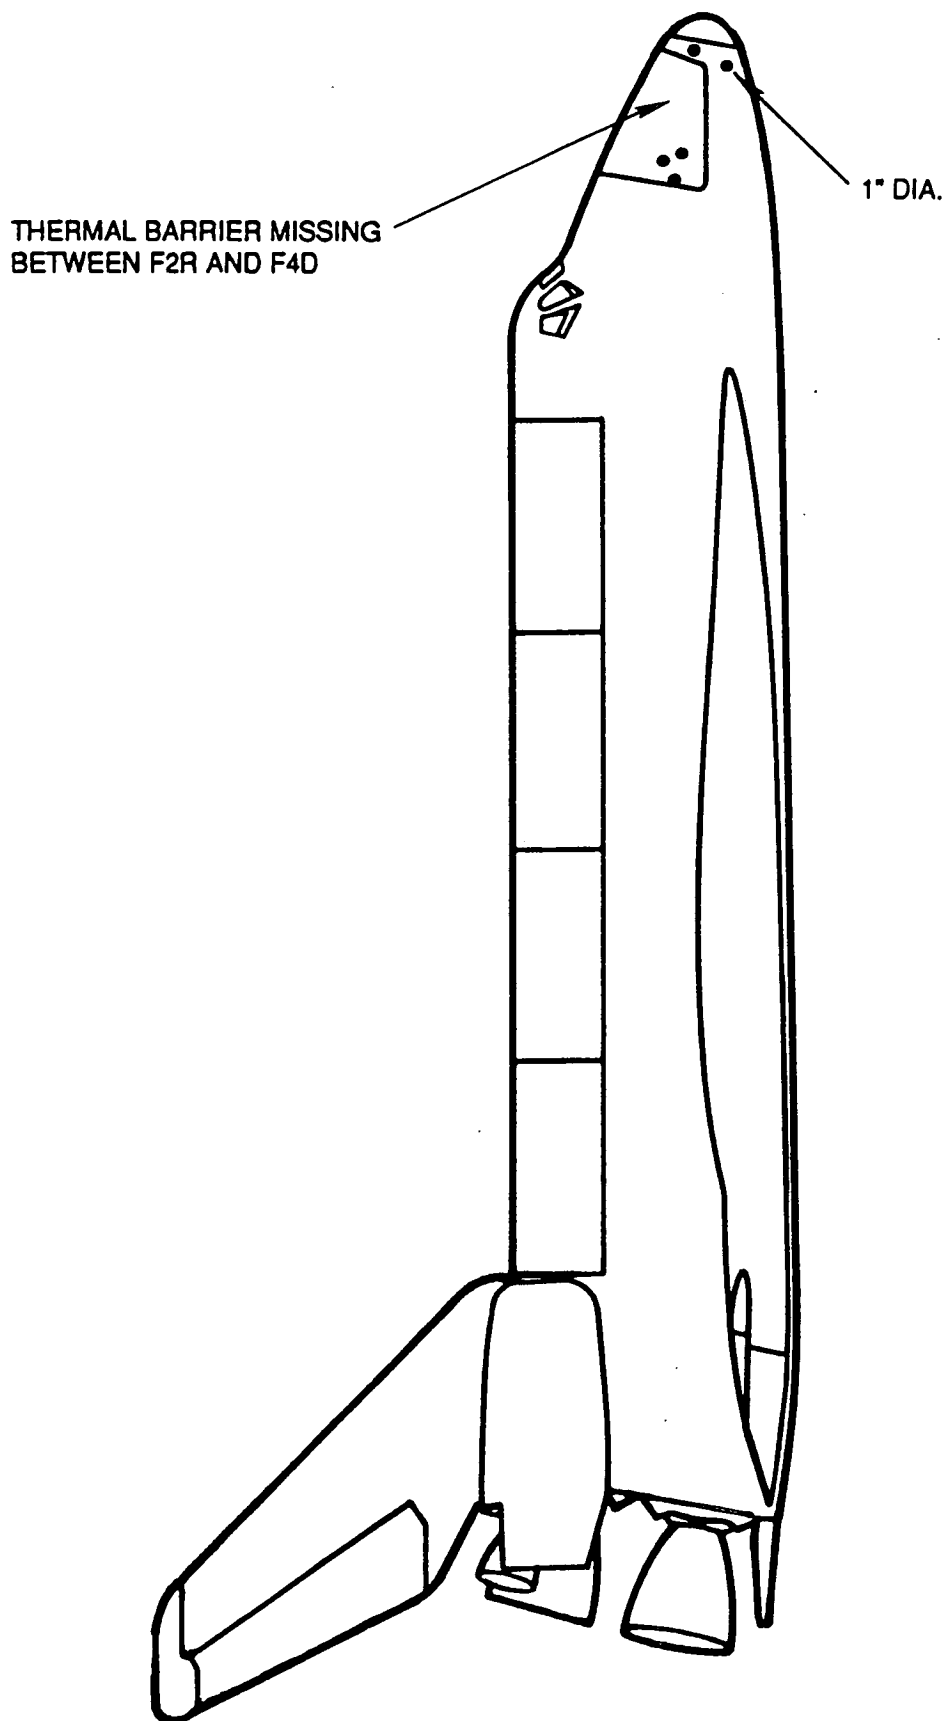
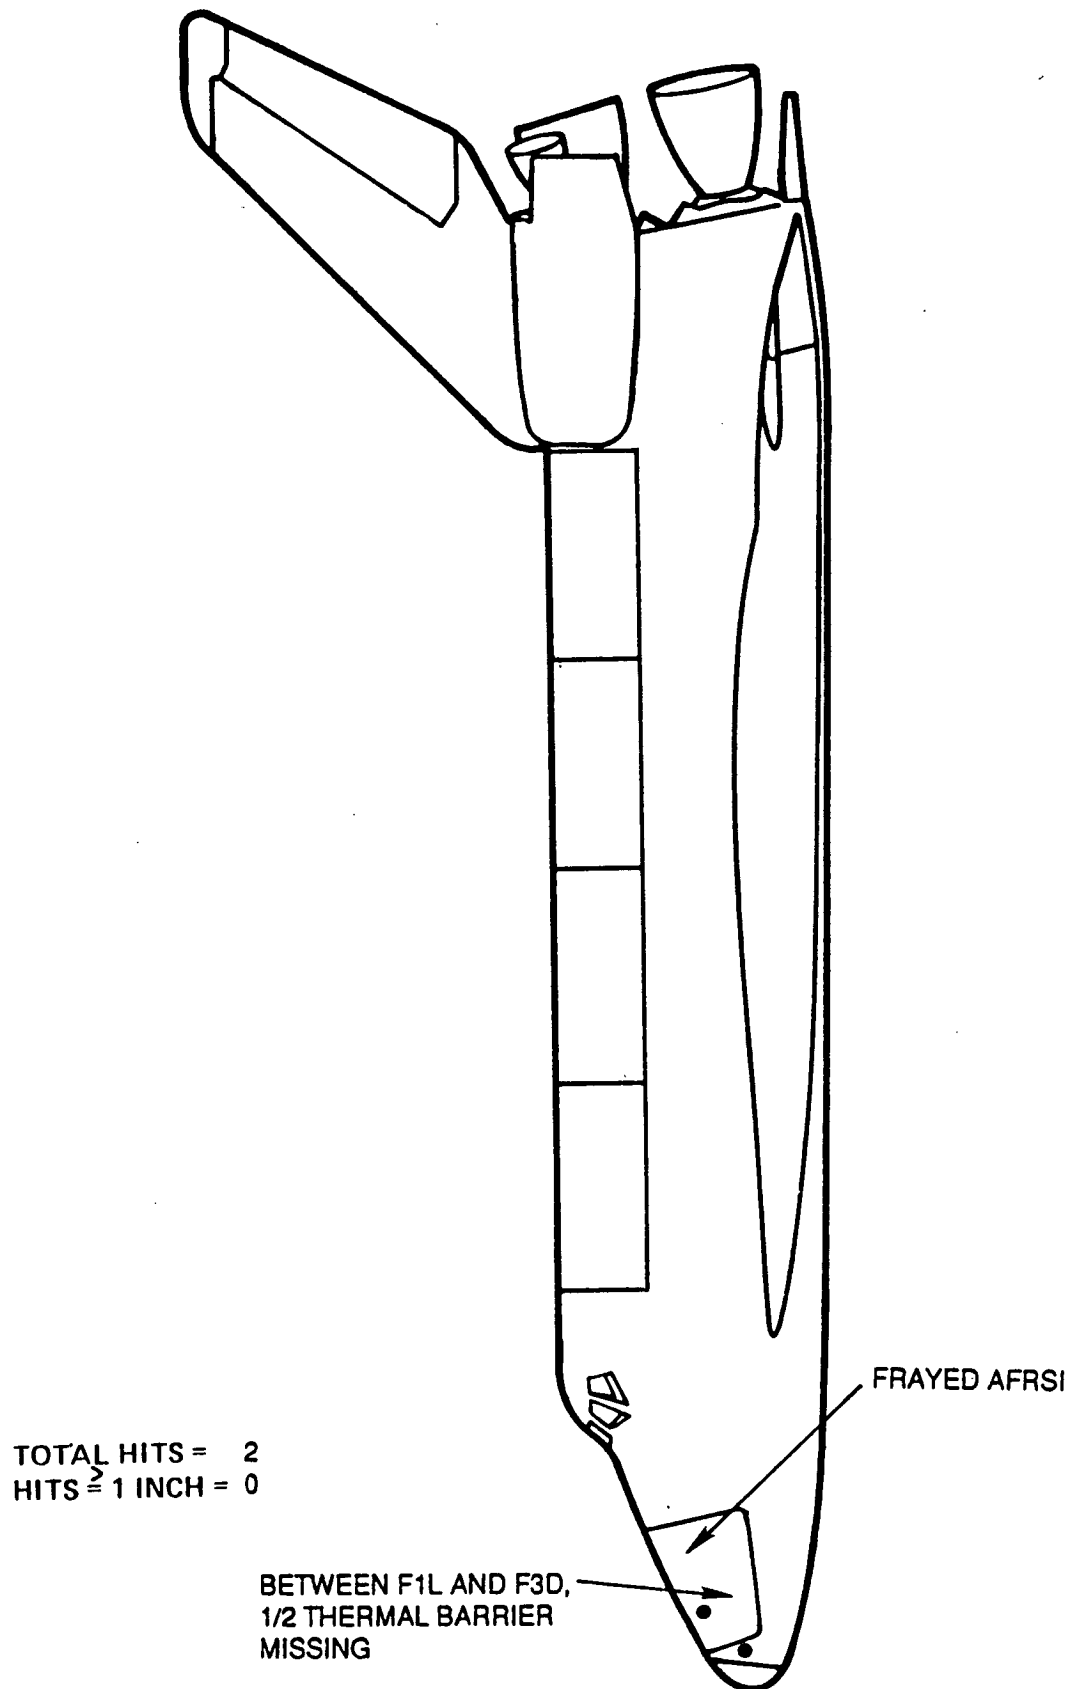
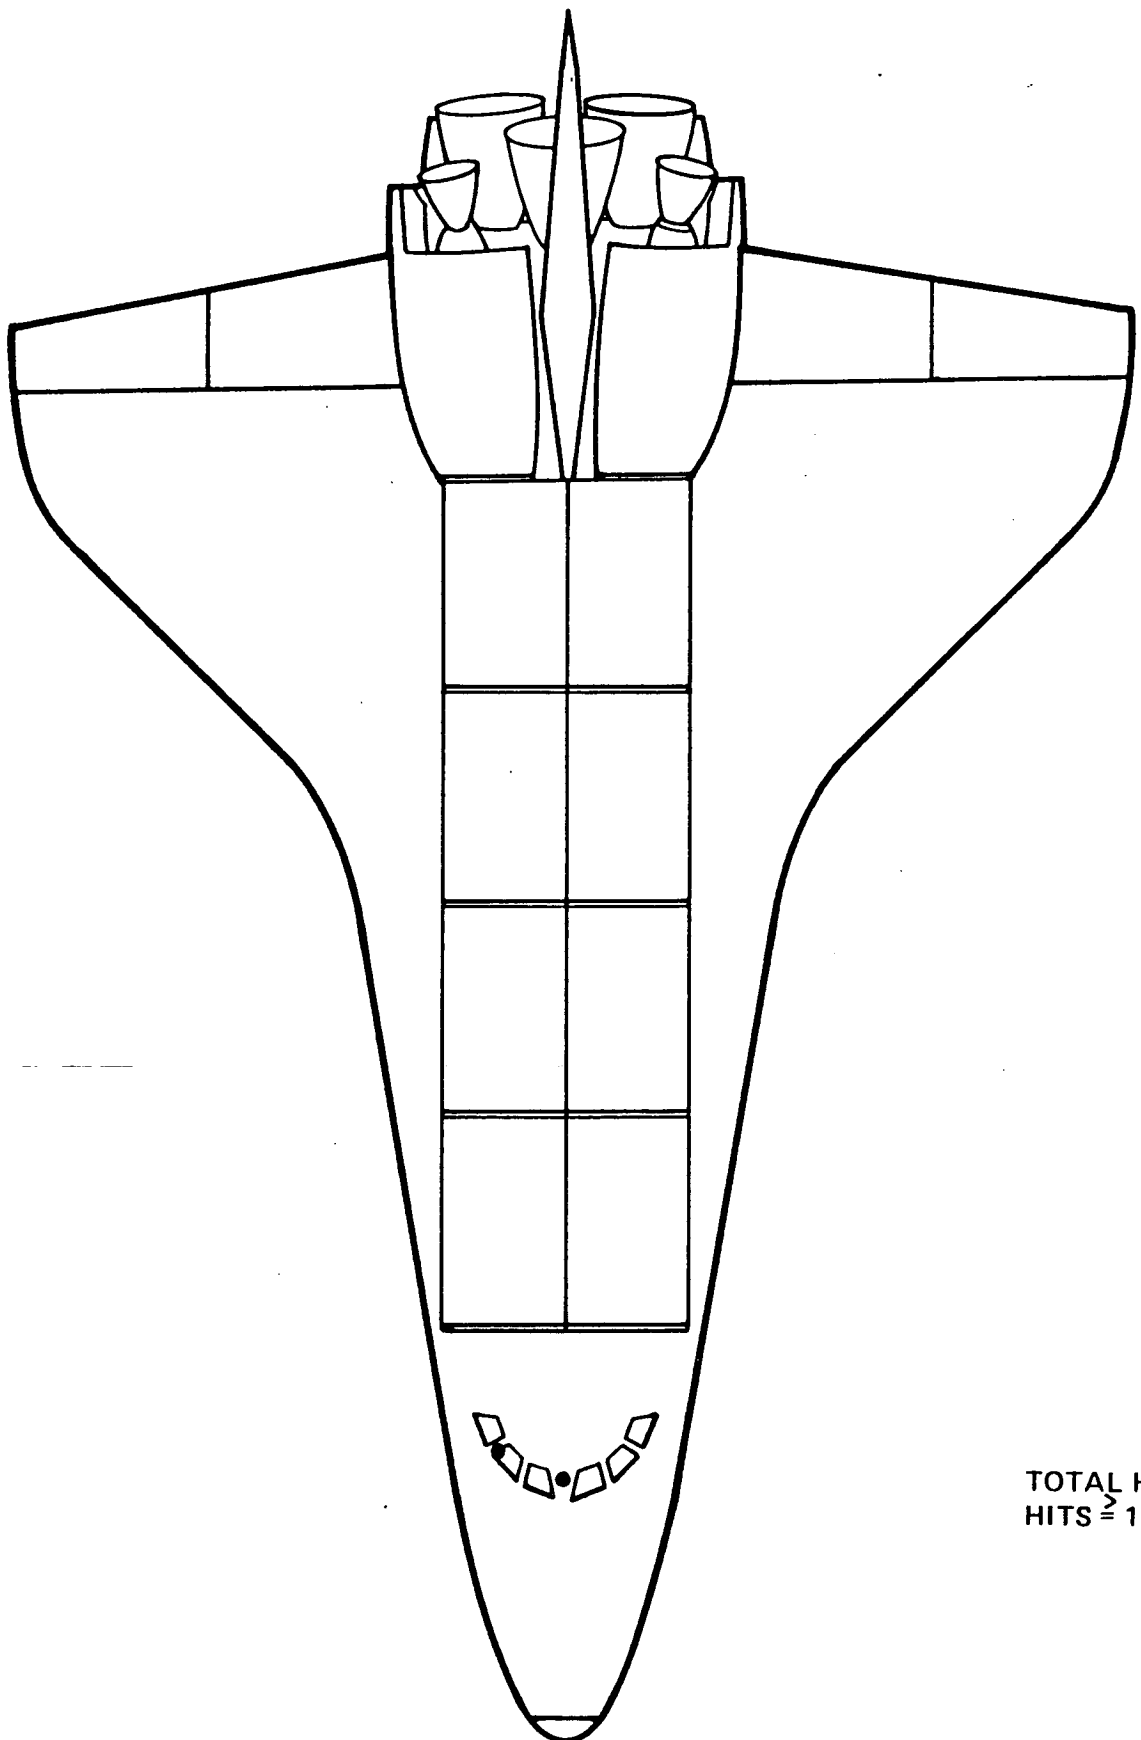
FIGURE 15. STS-43 DEBRIS DAMAGE LOCATIONS

The Orbiter lower surface had a total of 122 hits of which 24 had a major dimension of one inch or greater. A comparison of these numbers to statistics from 29 previous missions of similar configuration (excluding missions STS-24, 25, 26, 26R, 27R, and 30R which had damage from known debris sources), indicates both the total number of hits and the hits one inch or larger on the lower surface was greater than average. Figures 15 through 18 show the TPS damage locations for STS-43.

The largest single damage site on the Orbiter lower surface occurred on the RH nose area below the forward RCS module and measured approximately 18" x 1" x 1/8" (spanned 6 tiles). This shallow hit is indicative of damage typically caused by low density material, such as ET SOFI. Post-separation ET photographs taken by the crew (DTO-312) showed only the -Y side of the tank and could not confirm the loss of ET TPS.

A cluster of 19 hits (with 7 larger than one inch) occurred just forward of the LO2 ET/Orbiter umbilical. Similar clusters of hits have been observed in this area on previous flights and may be attributed to ice from the LO2 feedline bellows or support brackets. A second cluster of 12 hits (with 4 larger than one inch) occurred just aft of the LO2 ET/ORB umbilical cavity and may be attributed to ice from the LO2 ET/ORB umbilical during ET separation and/or damage from purge barrier baggie and ice during ascent.
